Manhole Inspection Summary

Manhole # S13EE_034MH

Insp Date: **2/5/09 9:10 AM**

Location Address: **1318 BLOOMINGDALE RD** Cross Street: **BELMONT AVE**

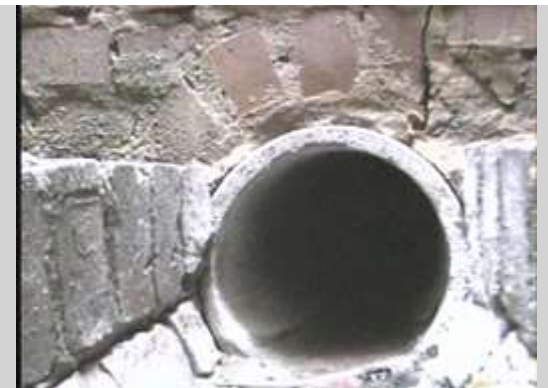
7 O'Clock Inflow

10 in. Circular Gravity Sewer
Pipe In @ 7 O'Clock

Pipe Height: **8.4** (in.) Rod and Bar (Angled)
Pipe Material: **Clay** ☐ Pipe Lined
Invert Depth: **6.84** (ft.) Flow Characteristics: **Slow**
Deposits: ☒ None ☐ Mud ☐ Sludge ☐ Debris ☐ Grease
Silt Depth: (in.) Deposits Extent:
Infiltration: **None** Pipe Seal Cond: **Sound**
